SUBJECT: Clutch Yoke 40-781 in
LA-5 and LA-6 machines.

DATE: July 25, 1934

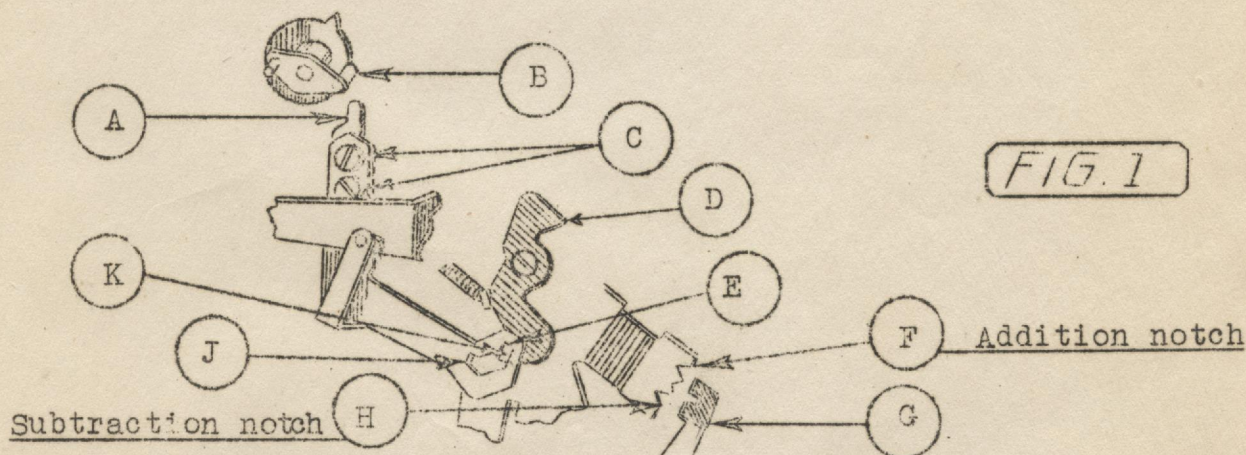
Continuous Running of Machine in Addition or Subtraction

This rocking motion is caused by the failure of offset (K) to unlatch from position (J) before the clutch yoke click enters the addition notch in the clutch yoke, thereby causing the 4708 blank (A) to continue in the path of the 4757 stud (B) on the crank arm. As the cycle stopping arm returns to the bumper pad after the final tripping of the trip lever the clutch yoke fails to neutralize due to the 4757 stud (B) engaging the 4708 blank (A) and causing the clutch yoke click (G) to seat in either the addition (F) or subtraction (H) notch in the yoke resulting in the machine running continuously.

To overcome this condition adjust the 4708 blank (A) to the 4757 (B) stud by loosening screws (C) and positioning blank (A) upward, downward, forward or rearward to suit in relation to stud (B) as follows.

- 1 When offset (K) is positioned at (E) and the clutch yoke click engages either of the three notches "add, subtract or neutral," the stud (B) should not engage the 4708 blank (A)
- 2 When offset (K) is located in position (J) and the clutch yoke click (G) is in the neutral notch of the clutch yoke, stud 4757 (B) should strike the rear of blank 4708 (A) with sufficient force to position the clutch yoke click (G) in the subtraction notch (H). When click (G) is in neutral, stud (B) should strike blank (A) and cause the clutch yoke click (G) to move into the addition notch (F). When (K) is in position (J), and (G) is in either of notches (F) or (H), stud (B) should not engage (A).

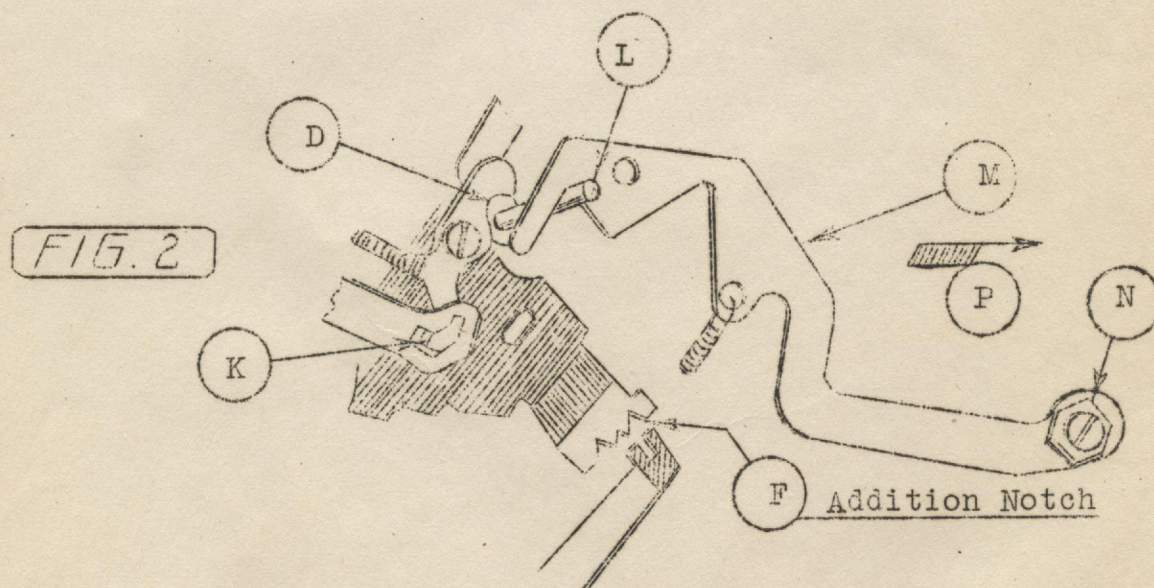
"Nines" Remaining in Lower Dials

This condition is caused by offset (K) unlatching too quickly, thereby causing the clutch yoke to neutralize instead of the clutch yoke click entering the addition notch thereby allowing the mechanism to make an addition cycle which would clear out the "nines."

This condition may be remedied by adjusting the division lever click (M) in direction of arrow (P) by means of eccentric nut (N) thereby increasing the clearance between the latch (D) and stud (L).

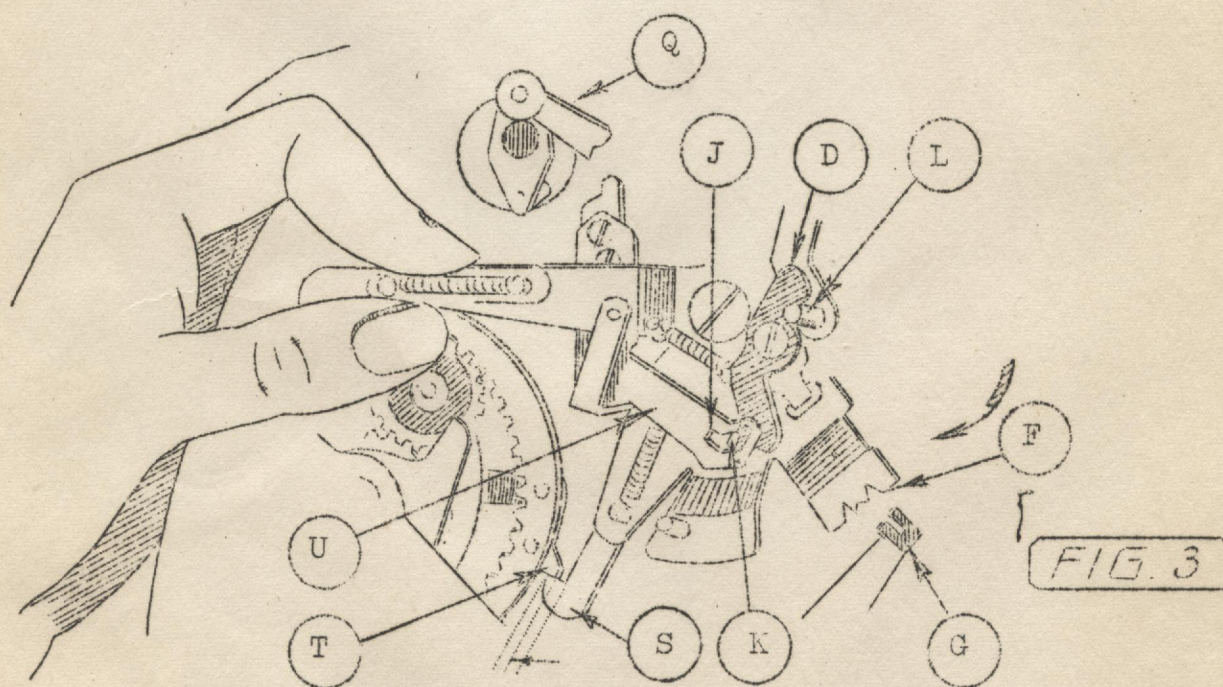
To test the clutch yoke mechanism proceed as follows. Rotate the motor governor until one ear (T) of planet gear arm assembly 27-726 is directly above the adding pawl (S) on the clutch yoke. Position crank arm assembly (Q) as shown below, move the division lever forward to set up the 40-716 (U), and then restore the division lever to neutral. Hold the planet gear in this position and move the clutch yoke SLOWLY into the add notch (F). While doing this, latch (D) will contact stud (L). A further movement of the clutch yoke will cause offset (K) to move slowly from the rear (J) of the slot in assembly (U). The offset (K) should not release until it is evident that the clutch yoke pawl (S) has approximately a one half hold on the ear (T) of the planet gear. Another test is to ascertain that offset (K) releases just a fraction sooner than the click (G) seats in the add notch (F). To accomplish the releasing of offset (K), eccentric nut (N), Figure 2 Plate 2, is provided. Movement of (N), Figure 2, Plate 2, will position (M), Figure 2, Plate 2, forward or rearward, thereby changing the neutral position of stud (L), against which latch (D) contacts.

Ascertain that excessive play does not exist in the left hand main carry shaft bearing #2447x1 and that when adjusting and testing the clutch yoke the throw of the yoke is balanced in both directions, otherwise a slight adjustment favoring the subtraction stroke may throw the adjustment completely off for the addition stroke.

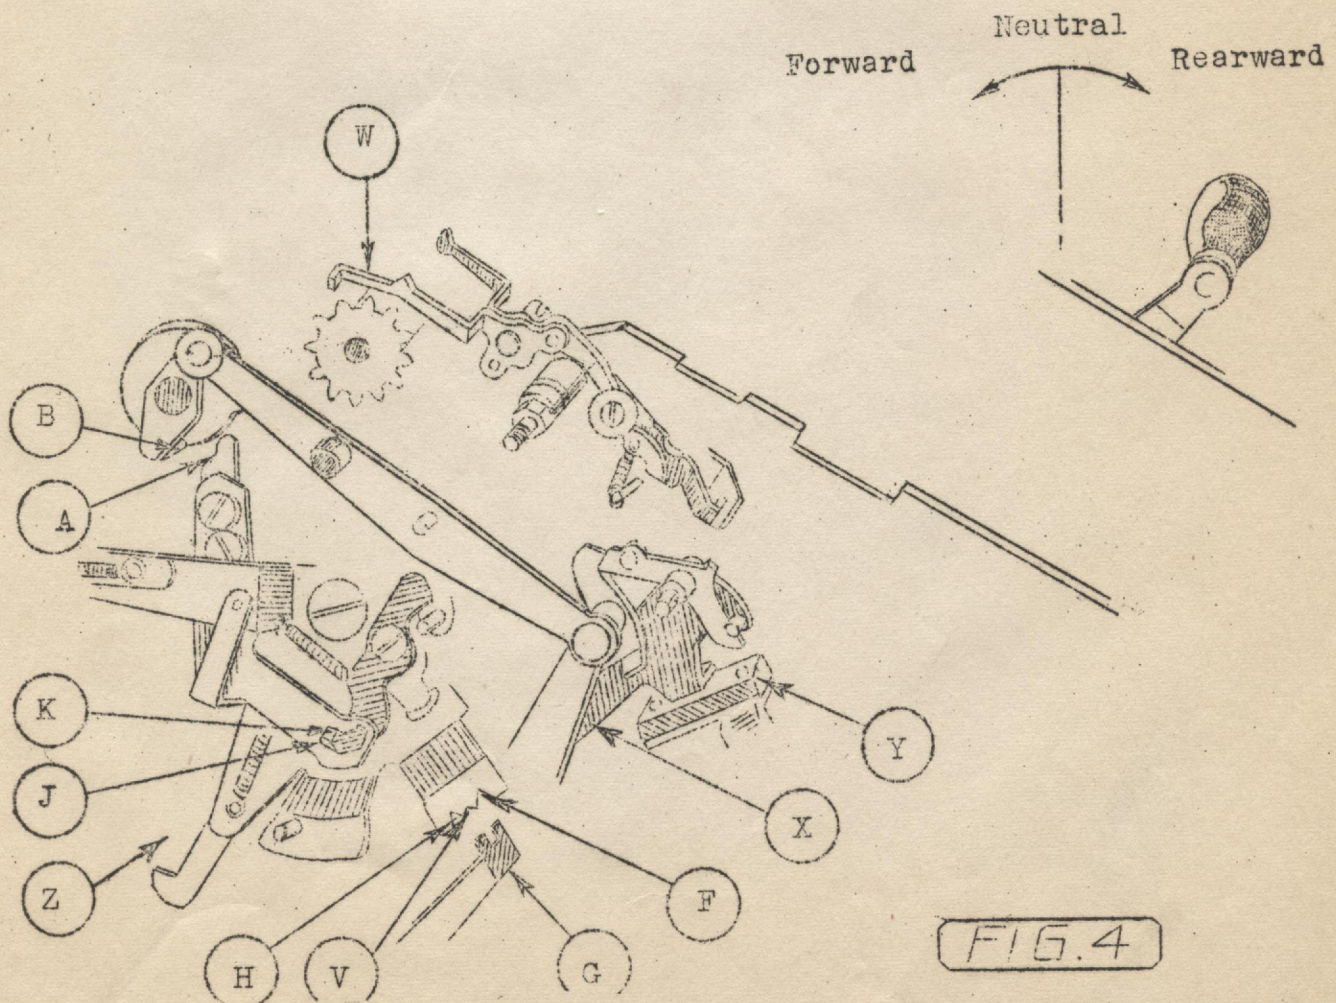
FIG. 4

A final test of the clutch yoke adjustments can be made as follows: With (K) positioned at (J), the trip lever (W) should be tripped and the machine turned forward with the hand crank until the cycle stopping arm (X) is positioned against the bumper pad (Y). The clutch yoke click (G) should then be positioned in neutral notch (V). When the cycle stopping arm (X) returns from the bumper pad (Y) to its neutral position, (A) should be adjusted so that (B) will locate the clutch yoke click (G) in the subtraction notch (H). There should be enough positive movement of (A) to cause the points of the notches to be carried past the clutch yoke click (G). It is advisable to have the movement of clutch yoke (Z) positive until (G) is seated in the proper notch. Ascertain that (B) does not engage (A) to the extent that the clutch yoke locks against a solid stop. With offset (K) positioned at (J), trip the trip lever (W) and turn the machine rearward with the hand crank until the cycle stopping arm (X) is positioned against the bumper pad (Y). The clutch yoke (Z) should then be in the neutral position (V). When the cycle stopping arm (X) returns from the bumper pad (Y), (B) should cam (A) so that the clutch yoke click (G) seats in the addition notch (F). This motion as nearly as possible, should be positive until (G) is seated in the proper notch, but not enough to cause the clutch yoke to lock against a solid stop.
